# Bloxwich Golf Club

ASSESSMENT OF COURSE DRAINAGE, JANUARY 2022

## ASSESSMENT OF COURSE DRAINAGE *Inspection Date 18 January 2022*

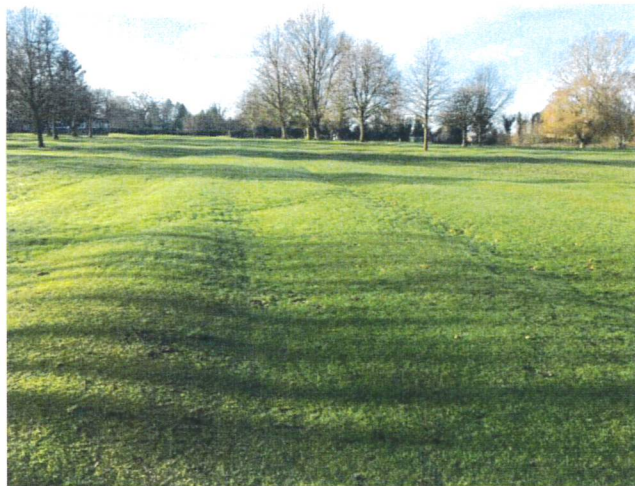
- 3.1 This challenging parkland course is close to 100 years old, originally established on former farmland, judging from the presence of gentle ridge and furrow contouring and old field boundaries.

*Photo 1: Ridge and furrow contouring*

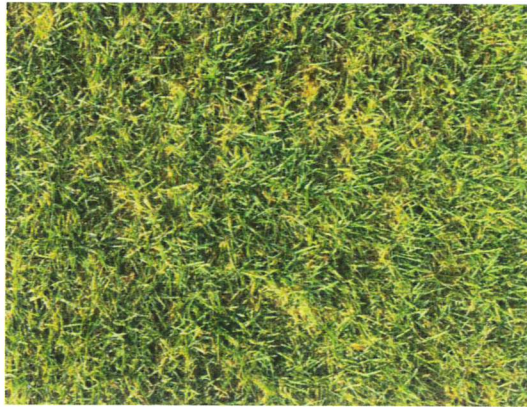
- 3.2 The fairways carry very good quality, mature turf, generally springy underfoot. All areas seen were comfortably walkable in mid-winter, although the lower sections of the 9<sup>th</sup> and 18<sup>th</sup> that were reported to have a high potential for flooding were somewhat softer than the norm. Scattered muddy patches were noted here and there, principally associated with zones of concentrated worm casting. Nevertheless, there was also wet/muddy turf associated with a small number of slow running or blocked drains.

*Photo 2: Very good quality, mature turf dominates the fairways*

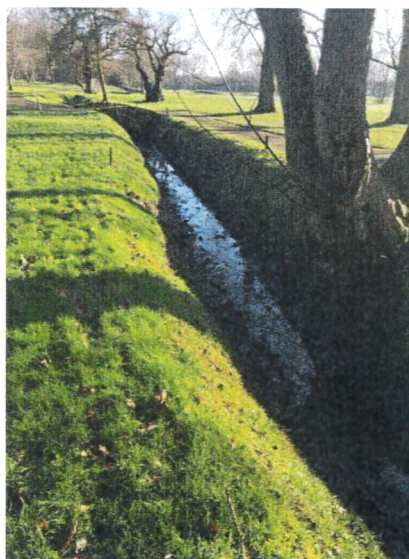
- 3.5 Existing course drainage relies on a system of ditches to carry ground water off-site. It seems there have been more ditches in the past, but a number have been (hopefully) piped and filled in. Of the remainder, it was evident these are well maintained on a regular basis. All were flowing freely and outfalls were clear.

*Photo 3: Well maintained, free-flowing ditches were seen throughout*

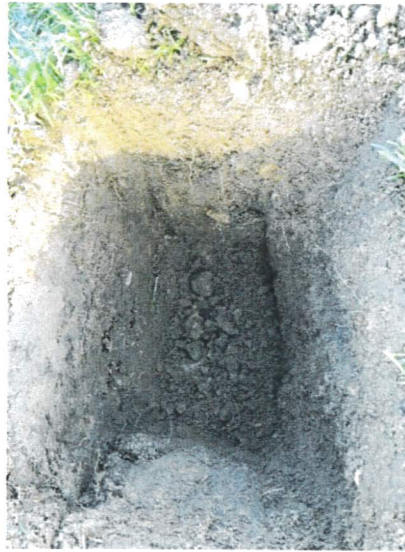
- 4.1 Sampling of the topsoil indicated the overall presence of a good depth (150-250 mm) of friable material that for the most part was uncompacted, merely moist and free of any mottling to suggest a fluctuating water table. This latter feature was only obvious in what tend to be the wetter parts of the 9<sup>th</sup> and 18<sup>th</sup>.
- 4.2 The friable nature of the topsoil to a 250 mm depth points to the regular implementation of an effective aeration programme to optimise the inherent drainage characteristics of the soil, as does root depth and exploration, which were both excellent. The subsoil beyond 250 mm was tighter (as would be expected) and, in comparison with the topsoil, more slowly permeable.

*Photo 4: Sampling indicates the presence of a good depth of topsoil*

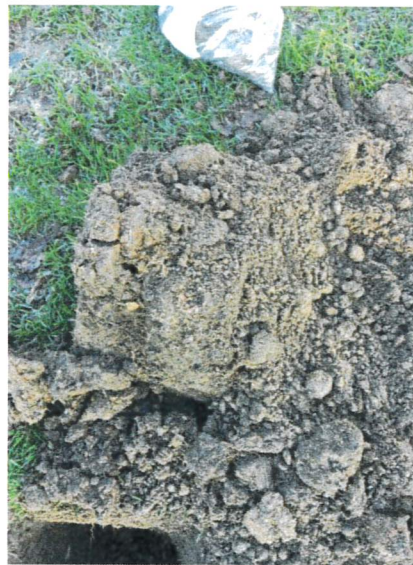
*Photo 5: The soil is generally friable, has a good colour and permits extensive root exploration*

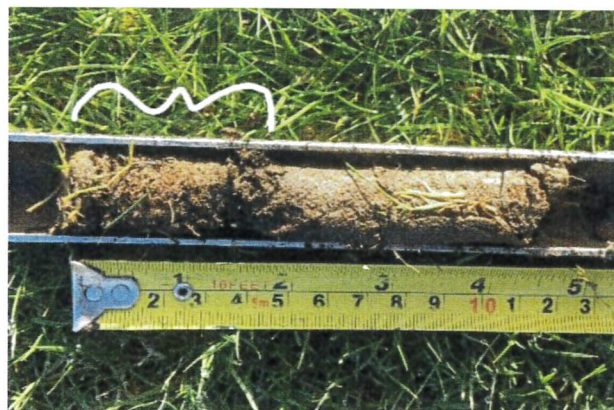
- 4.4 Overlying the topsoil is a layer of thatchy organic matter around 50 mm thick. While this will give the turf a springy feel in dry conditions, in wet weather it will inhibit infiltration of ground water, slowing percolation into the soil and promoting run-off to low points that will form pools that are slow to disperse. The build up of such thatch is inherent in the nature of the turf and is promoted by the acidity of the topsoil.

*Photo 6: A thick thatch layer impedes infiltration of surface water*

- 5.3 A more appropriate approach to enhancing drainage throughout the course will be to intensify surface maintenance to make the initial infiltration of rainwater much faster. As I see it, your basic issue is not that the drains present are inadequate, but that ground water does not get to them quickly enough, primarily because there is an excess build-up of thatch between the grass and the topsoil.

- 5.4 To bring about thatch reduction, I recommend adding an intensive scarification programme to the treatment plan for fairways in both spring and late summer, using a machine that will closely follow contours to minimise the risk of ancillary damage. Looking at what tractor-mounted equipment is on the market, I think the best option is the Sisis Veemo Mk 2 triple unit, although the Graden Swing Wing could be trialled as well. You might have a first go in coming weeks by bringing in a contractor with a Veemo to do this for you, before investing in a new machine. ALS provide this service. See:

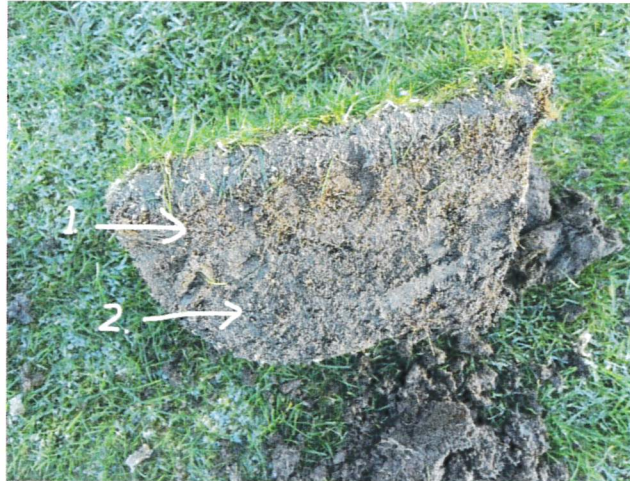
- 4.5 This thatch layer is at its thickest and wettest where it is associated with localised topsoil compaction in the wet zones of green surround at the 11<sup>th</sup> and 16<sup>th</sup>. Underneath this 100 mm layer of locally damaged soil the ground was just moist and friable, not saturated. There was no sign whatsoever of spring water coming up from lower levels.

*Photo 7: Saturated thatch (1.) over wet, compacted topsoil (2.) at the 16<sup>th</sup>*

- 5.6 Turning to the wet green surrounds at the 11<sup>th</sup> and 16<sup>th</sup>, here there are drains, but damaged soil is further impeding downward percolation of ground water in addition to a very thick thatch layer. Past experience suggests the best cure will be to strip off the turf and thatch, cultivate the exposed soil, mixing in extra sand, and then returf with fresh material. However, as discussed, you could try hollow tining or vertidrainage and working in heavy dressings of sand in the first instance, when ground conditions permit.

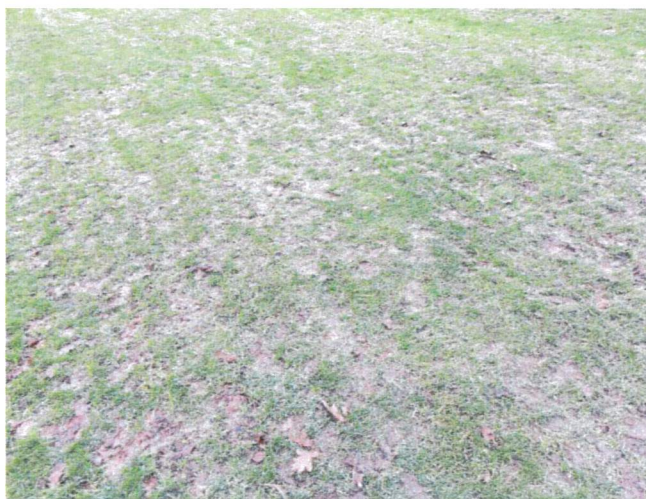
- 5.8 Lastly, also affecting the apparent drainage qualities of the course are patches of concentrated wormcasting. See Photo 8. As things stand there are no good treatments to resolve this issue, nor is something really effective likely to appear in the future. There are soil conditioners you can apply to discourage worm casting, e.g. Purity or TAG can have a very short term effect, but they are no means guaranteed to work and are expensive. As such, given the scale of the problem, my suggestion is simply to top dress these places with gritty sand as and when necessary, and to consider overseeding in spring where the grass is particularly thin.

*Photo 8: Superficially, heavy wormcasting can have the appearance of poor drainage*

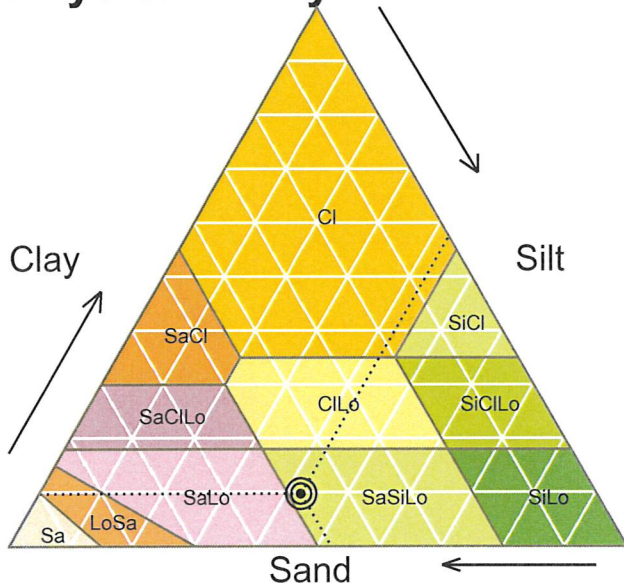
Analysis	Result (%)
Sand	47.82
Silt	42.45
Clay	9.73
Very Fine Sand	17.58
Fine Sand	19.81
Medium Sand	9.85
Coarse Sand	0.58
Very Coarse Sand	< 0.01
Stones >2mm	6.00
Soil Type	SaSiLo Sandy Silt Loam

Property	Assessment
Available Water	Low to Medium
Drainage Rate	Rapid
Inherent Fertility	Low to Medium
Potential C.E.C.	Low to Medium
Leaching Risk	High to Moderate
Warming Rate	Rapid
